# Manhole Inspection Summary

Manhole # S49AA\_045MH

Insp Date: **7/10/08 12:06 PM**

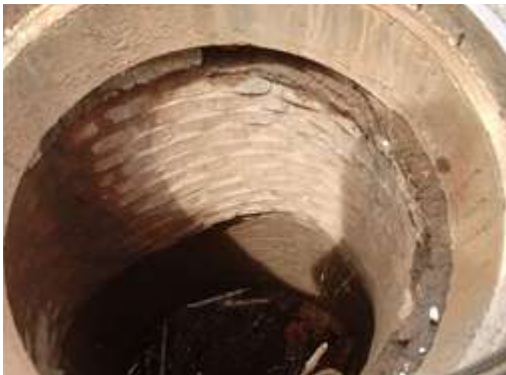
Defect 2

Condition: ☐ Sound ☐ Cracked ☐ Root Intrusion ☒ **Loose Brick** ☐ Deteriorated

loose brick

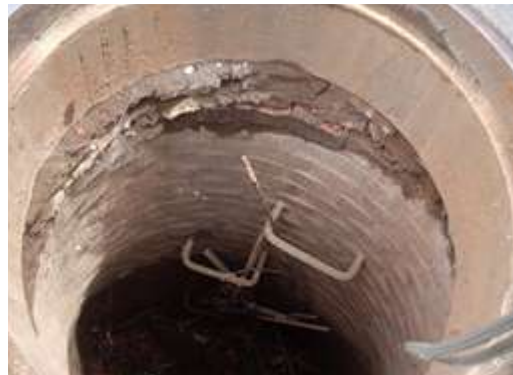
Defect 1

frame leaks

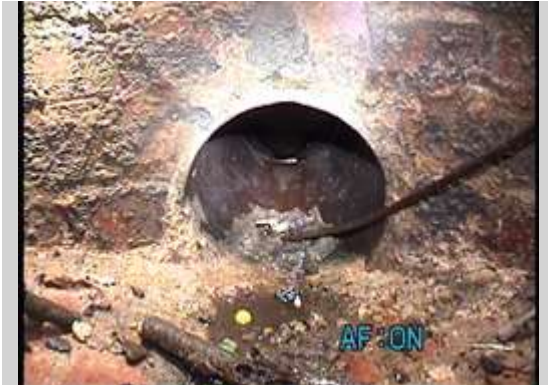
12 O'Clock Outflow

8 in. Circular Gravity Sewer  
Pipe Out @ 12 O'Clock

Infiltration: **None** Pipe Seal Cond: **Sound**
